# Stage One Desk Study: Drury South Business Project - Contaminated Land Assessment

Prepared for Stevenson Group Ltd (Client)

By Beca Infrastructure Ltd (Beca)

17 December 2010

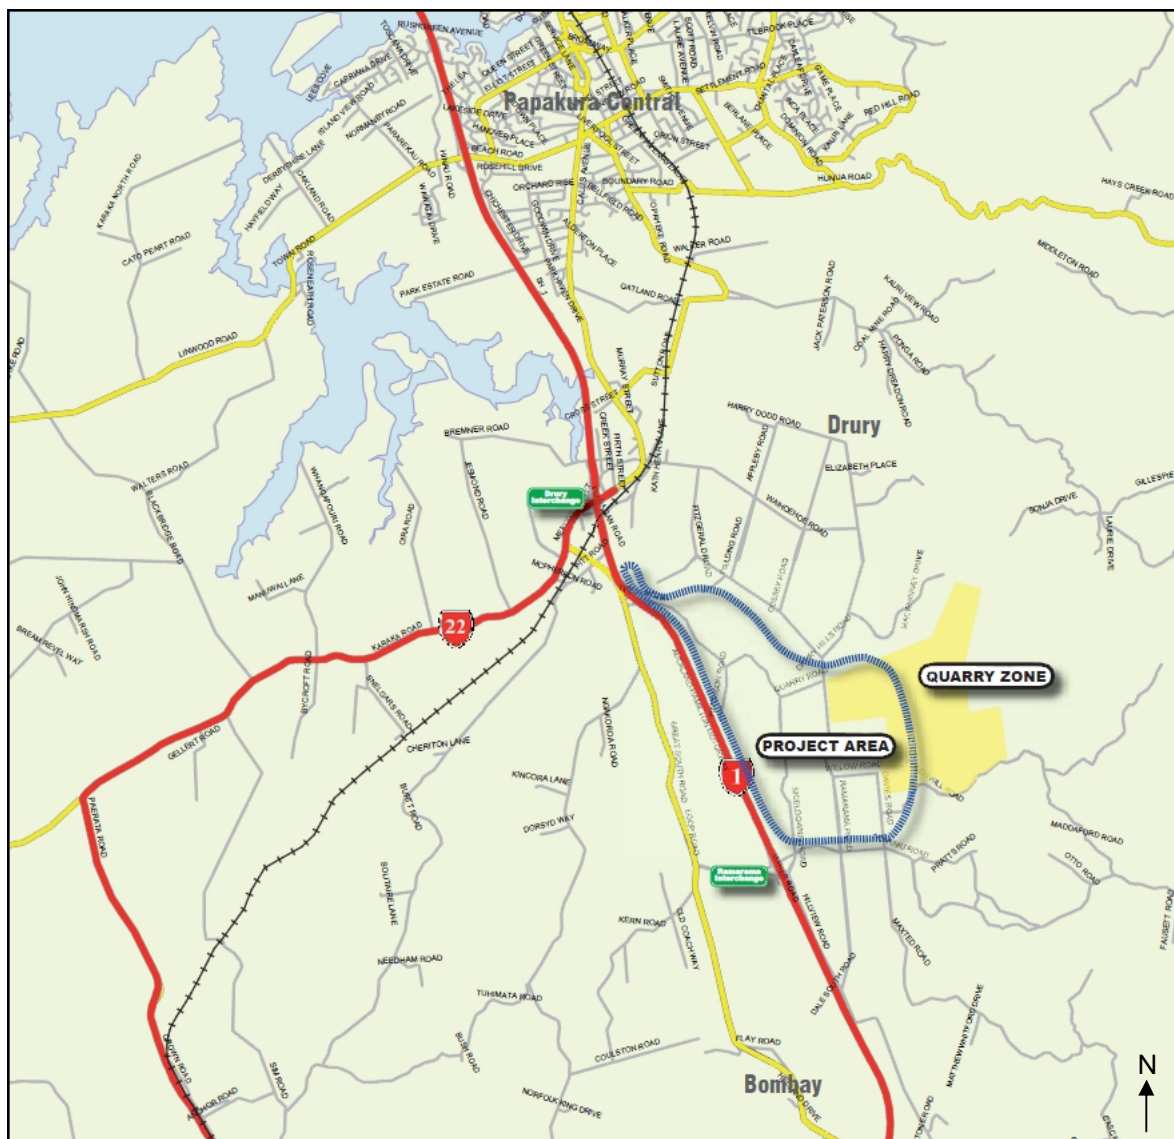
**Figure 1 Location of Drury South Business Project**

The Drury South Business Project (DSBP) proposes the development of approximately 223 Ha of 'Land Extensive Business Activity' land (within a total study area of around 361 Ha), which is anticipated to provide employment for approximately 6,880 people when fully developed (around 2025-30). The project is located in the Drury basin, to the east of the State Highway 1 Motorway (SH1), between Drury interchange in the north, and Ramarama interchange in the south. The DSBP area lies within the Franklin Ward of the Auckland Council and across the boundary between the Papakura and Franklin District Plan areas. Drury Quarry is located at the base of the Hunua foothills on the eastern edge of the project area, with the Quarry Zone extending into the project area. Figure 1 shows the location of the project.
